Illinois Commerce Commission
Assessment of AmerenIP's
Reliability Report and Reliability Performance
for Calendar Year 2004

Pursuant to 83 Illinois Administrative Code 411.140

November 10, 2005

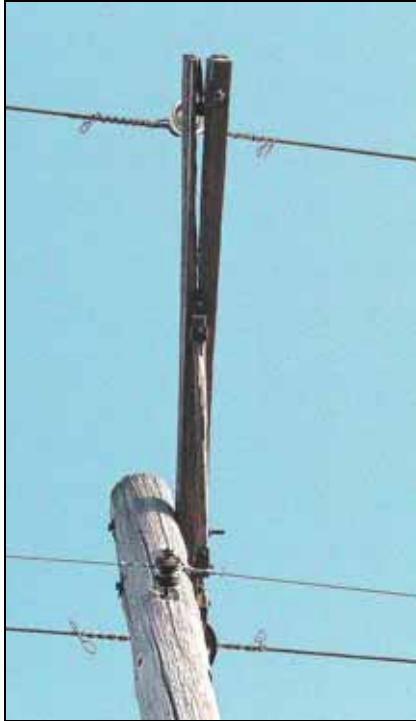
Figure 4 (Photo 05A15)
Badly split crossarm,
Circuit 502, Rd. 1900E, south of Mayview

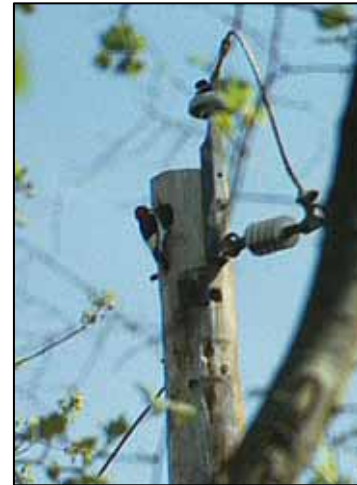
Figure 24 (Photo 05F25)
Several woodpecker holes in pole top
& woodpecker working on the pole,
Circuit 915, northeast of Chester

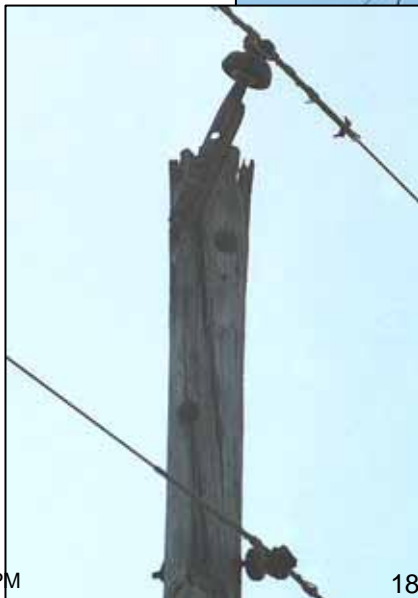
05G3) Split pole top w/ 2
holes,
Cir. 915, Union
Chester

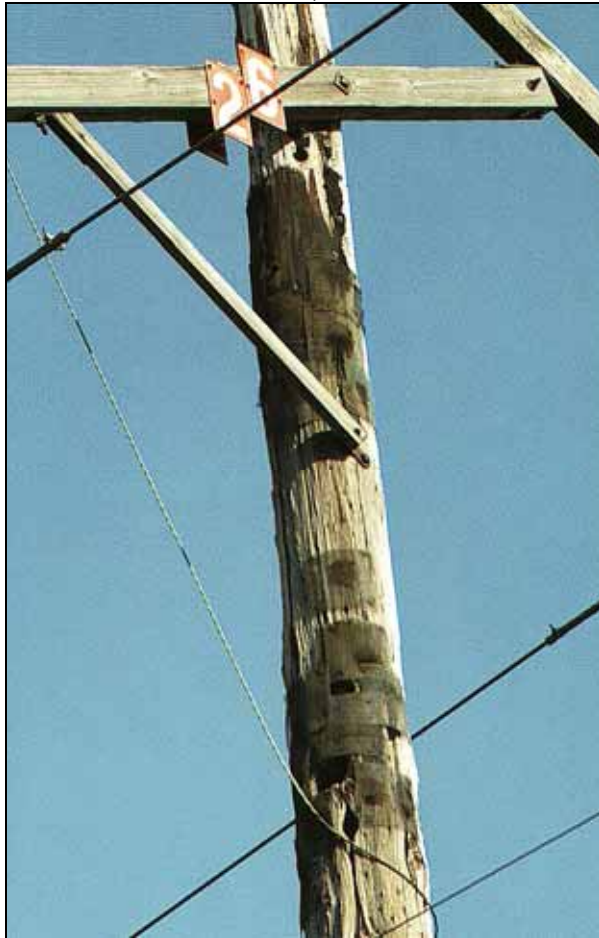
Figure 44 (Photo 05J14)
4 woodpecker holes in 69 kV Str. 16
(above Circuit 331 crossarm),
Woodland Lakes Rd., N. of Jacksonville

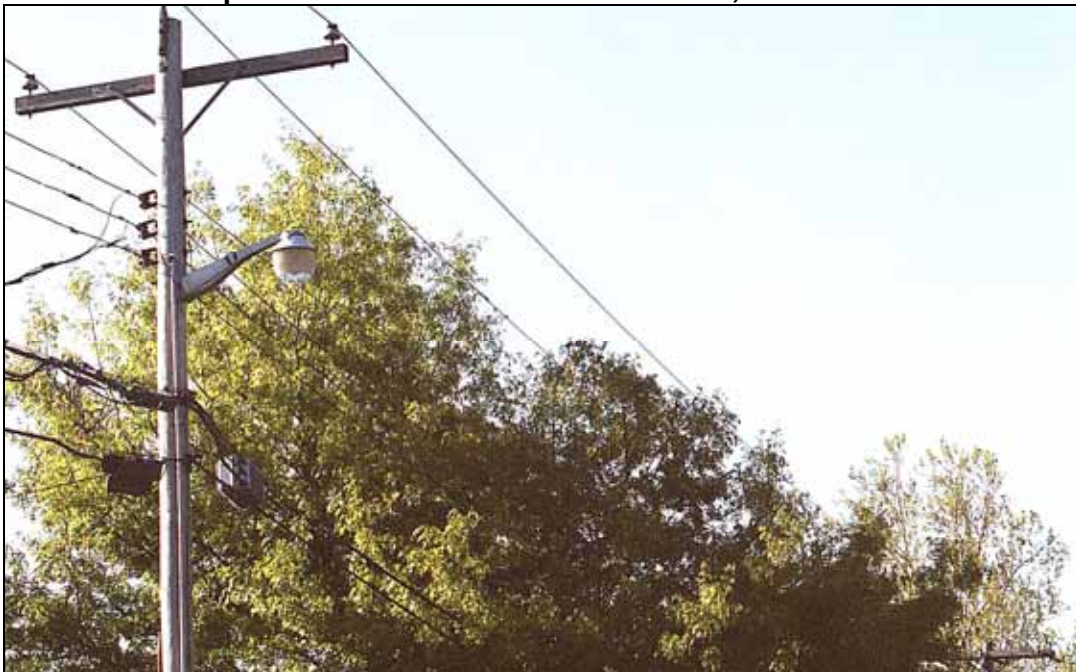
Figure 1 (Photo 0514)

Pin oak tree into primary

1st span north of E. State St. on Howe St., Jacksonville

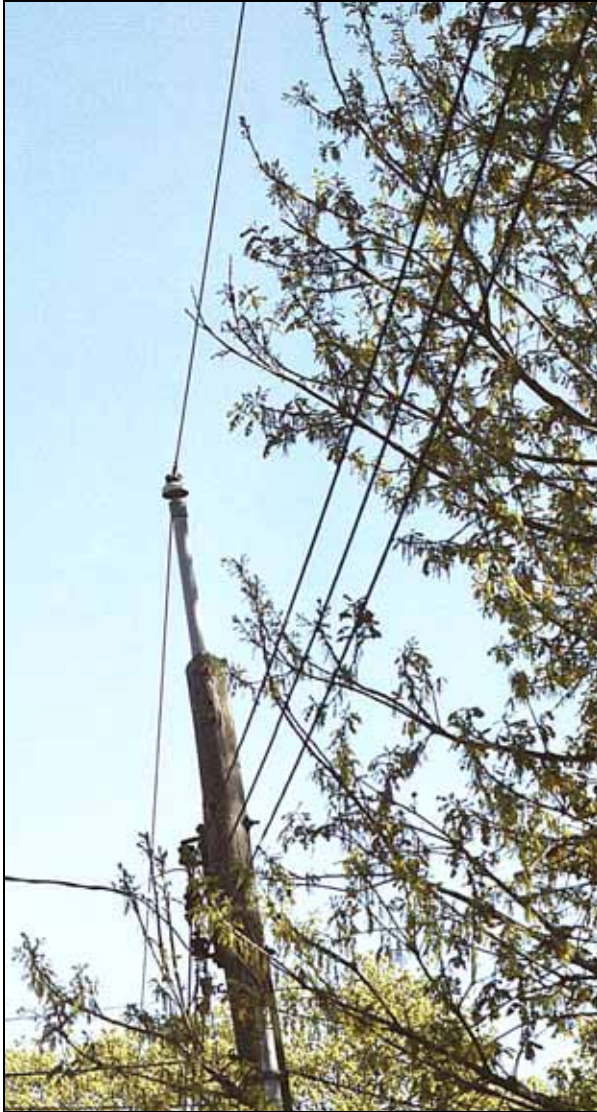
Figure 2 (Photo 0517)

**Oak tree growing into primary
Doolin Ave. S. of Oak St., Jacksonville**

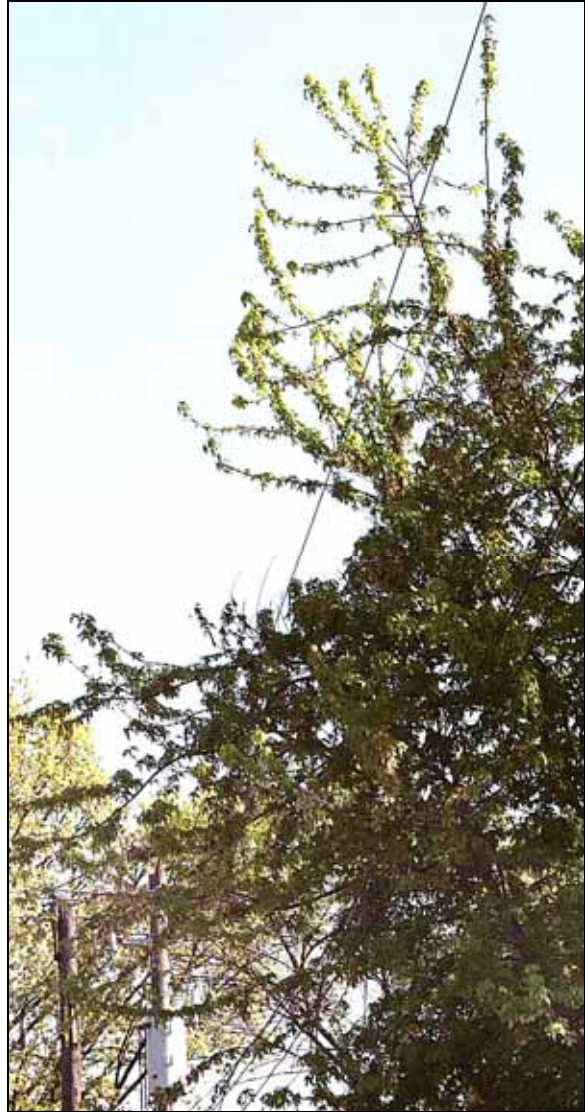
Figure 3 (Photo 05110)

**Soft maple tree growing into primary
Doolin Ave. S. of Oak St., Jacksonville**

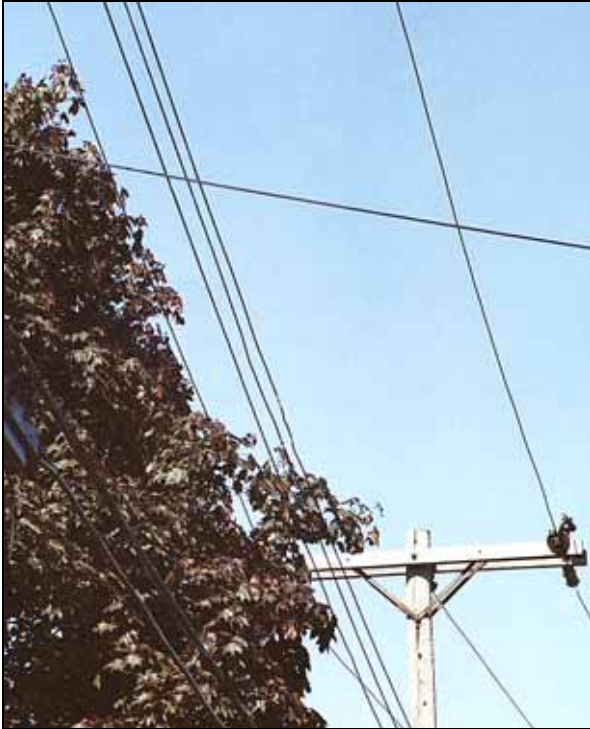
Figure 4 (Photo 05I11)

**Crimson King maple growing into primary
Freedman St. E. of Cherry St., Jacksonville**

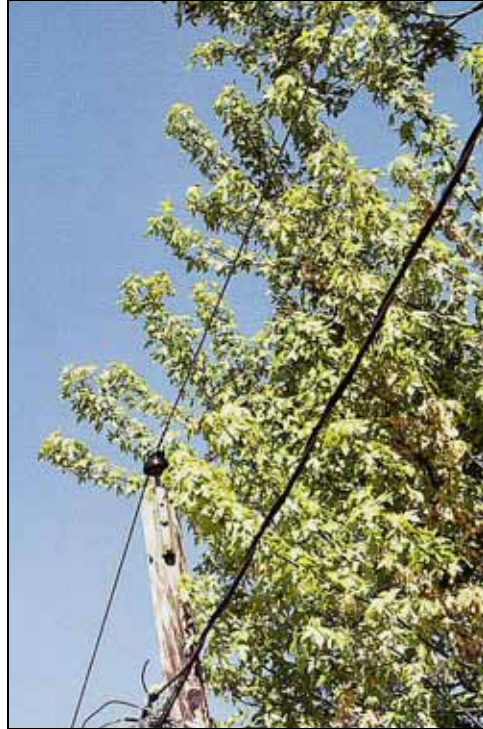
Figure 5 (Photo 05I14)

**Soft maple tree very close to primary
Center St. E. of Green St., Jacksonville**

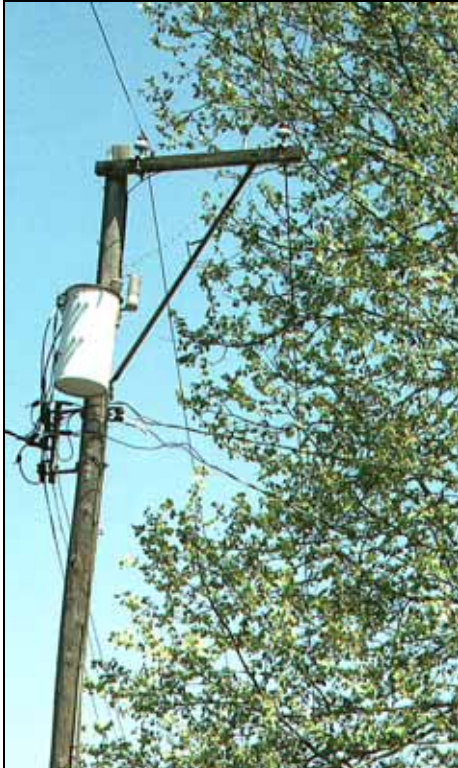
Figure 6 (Photo 05J2)

**Primary through sycamore tree
Main St. S. of Independence, Jacksonville**

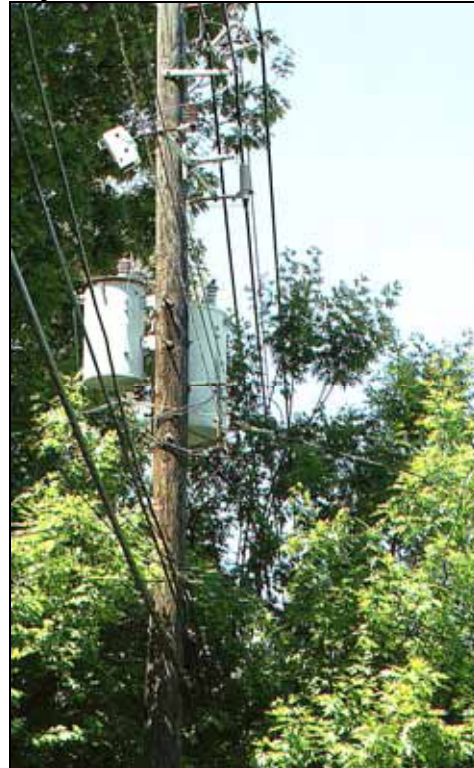
Figure 7 (Photo 05J6)

**Oak tree into spacer cable primary
Lafayette W. of Bedwell, Jacksonville**

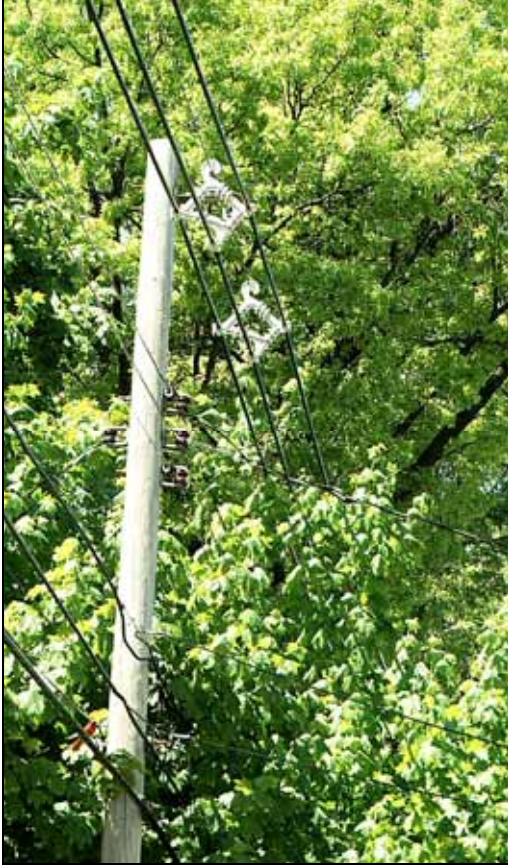
Figure 8 (Photo 05J8)

**Hard maple tree into spacer cable primary
Lafayette St. west of Bedwell, Jacksonville**

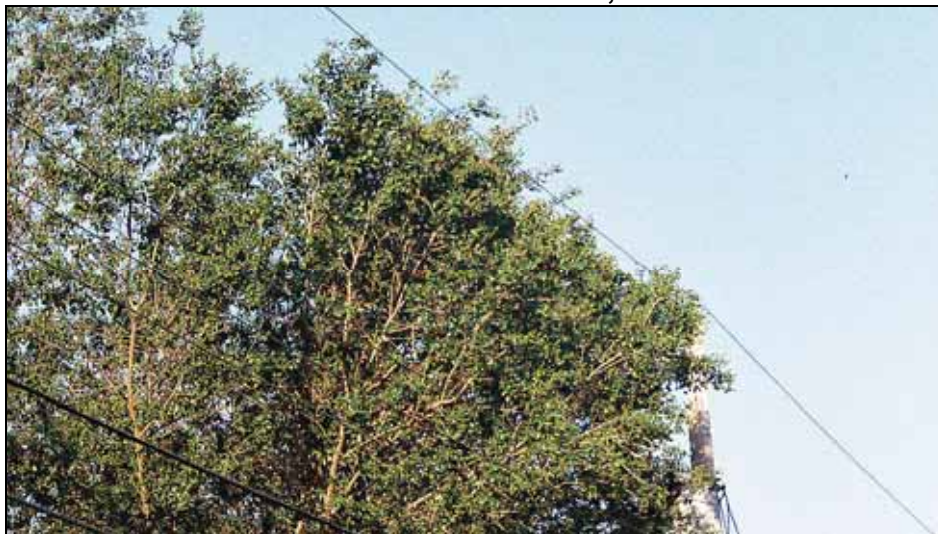
Figure 9 (Photo 05K2)

**Siberian elm tree into single-phase primary
Garfield Ave. east of 24th St., Decatur**

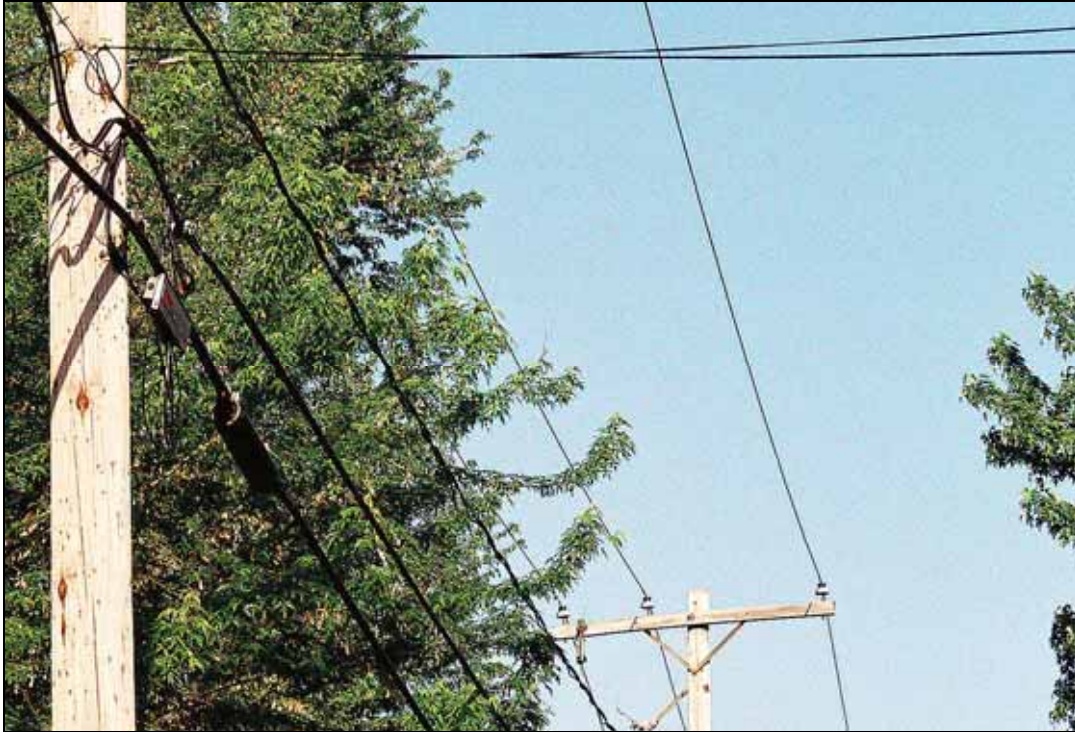
Figure 10 (Photo 05K4)

**Soft maple tree growing into 3-phase primary
Garfield Ave. between Union & Edward Sts., Decatur**

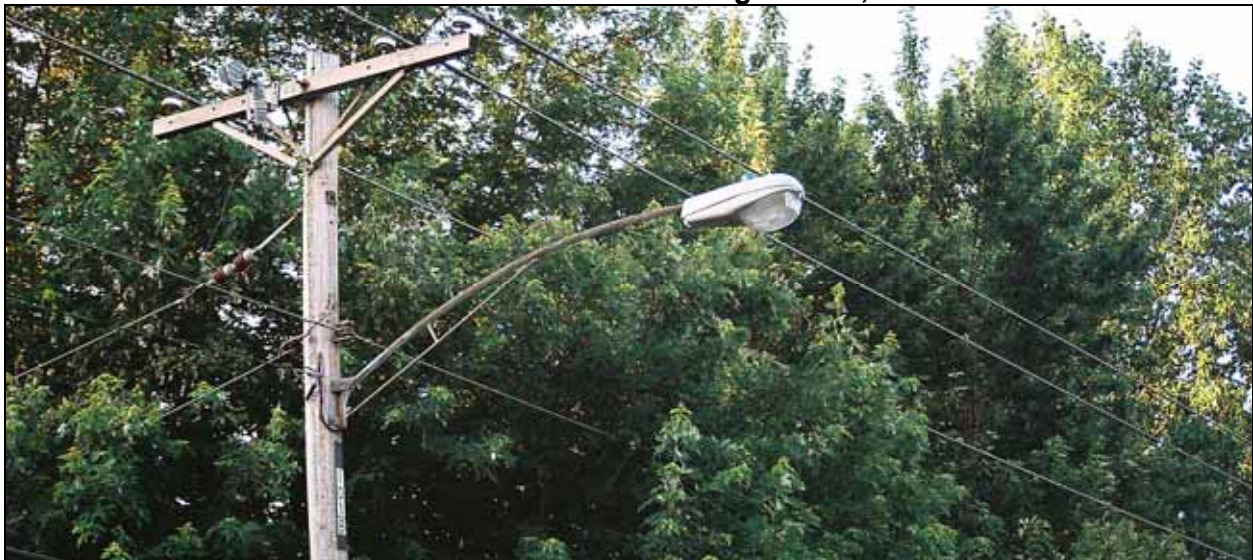
Figure 11 (Photo 05P6)

**Soft maple trees growing into 3-phase primary
N. MacArthur Rd. north of Buckingham Dr., Decatur**
